**Service Letter No: SL-200C/400C-013015**

**SUBJECT:** Actuating pin base to outer ferrule attachment bolt hole depth.

**MODELS AFFECTED:** Model 200C; all propellers with blade serial numbers 200C-385 and lower Model 400C; all propellers with blade serial numbers 400C-226 and lower

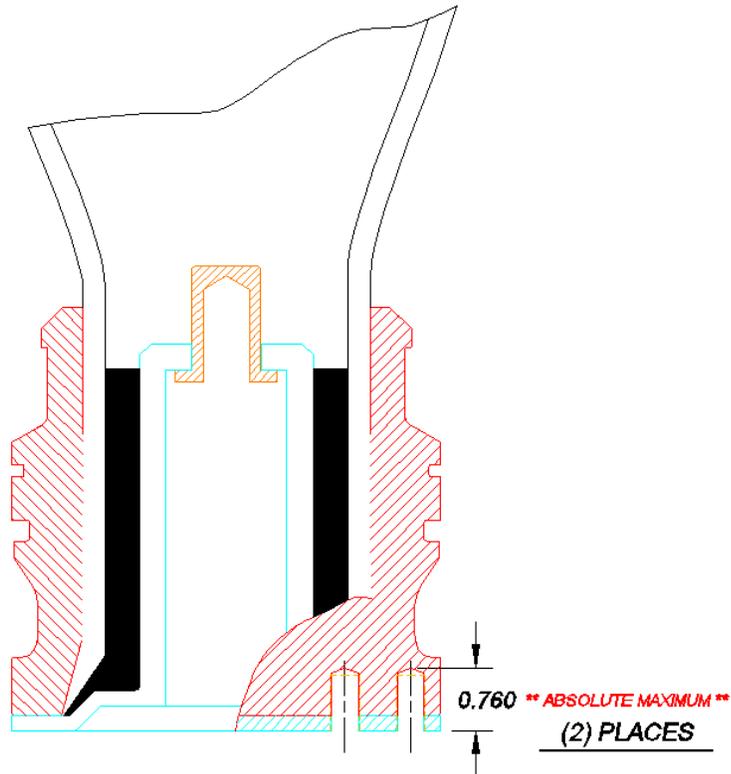
Figure 1

Through testing and / or removal of the 5/16-24 actuating pin base mounting screws the drill depth of the screw holes must be found **not to exceed 0.760"** deep from the surface of the inner ferrule to the drill point (see figure 1 below). Blades with holes exceeding this maximum allowable depth must be taken out of service immediately.

**200C / 400C SERIES PROP BLADE  
ACTUATING PIN BASE MOUNTING HOLE**

Blade ferrules that have actuating pin base holes with maximum depths of 0.760" and less and are NDT tested and verified to be structurally sound (no evidence of cracks) may be returned to service, continuing to follow the propeller 250 hour or annual tear down inspection service interval, whichever comes first.
